CASE STUDY NO 10

Retail Insulated Loading Dock Doors

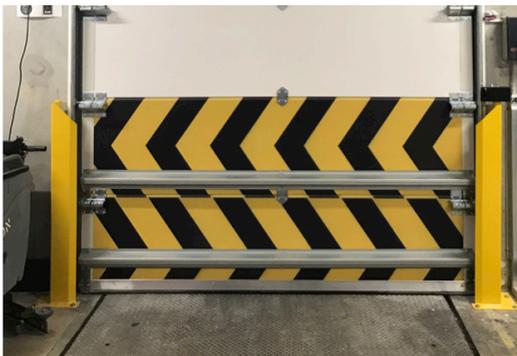
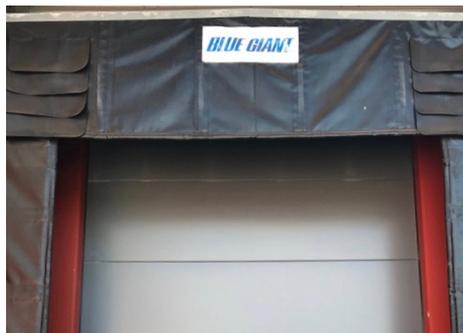
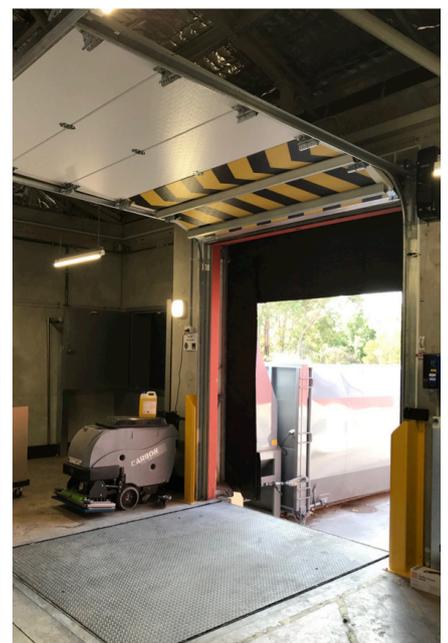
AFTER PHOTOS

It has been three months since the new 'Door' has been installed and there has not been a single breakdown component failure or part failure, and there is not a single scratch or dent on the door; every feature we have specified is valid and works. The new 'Door' has improved the safety for the operators as well as eliminating unnecessary repairs; the specified features have created cost savings for the customer and improved store and loading dock operations and safety overall.

For the trial of the new 'Door' we supplied and installed the new door into their retail store with very high door repair costs and breakdown attendances, this was a deliberate choice to target the worst case store and demonstrate just how good our door design was.

The installation of the new 'Door' took six (6) hours, due to the thorough study, planning and correct specification, including the removal of the old existing door. The installation was completely trouble free, and the new 'Door' worked perfectly from the start without any glitches.
